PRELIMINARY NONDESTRUCTIVE EVALUATION MANUAL FOR THE SPACE SHUTTLE

**PRELIMINARY NONDESTRUCTIVE EVALUATION MANUAL
FOR THE SPACE SHUTTLE**

APPENDIX TO FINAL REPORT

**LOCKHEED-GEORGIA COMPANY
A DIVISION OF LOCKHEED AIRCRAFT CORPORATION
MARIETTA, GEORGIA 30063**

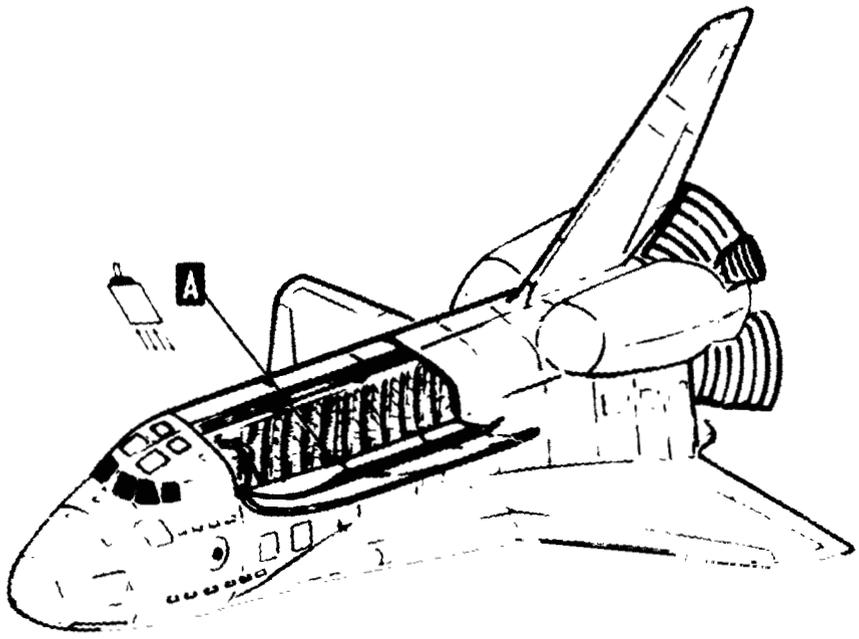
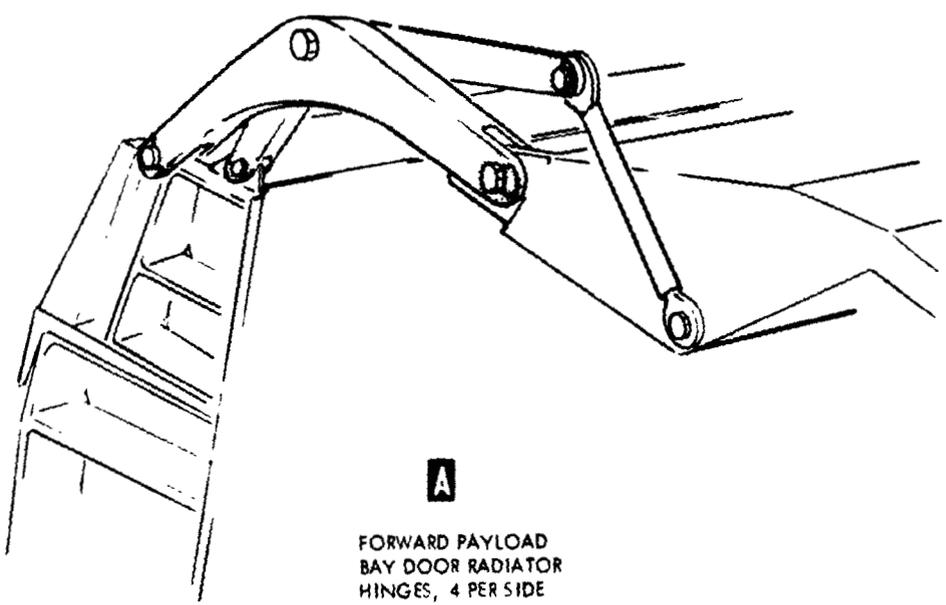
Figure 3-5. Forward ECS Radiator Panel Hinges

The ECS radiator panels are structurally supported at the inner surface of the payload doors and are deployed by opening the payload doors in orbit. There are two radiator panels per payload door section (four per side), hinged to the mid-fus hinge longeron only on the fwd door sections. Each panel on the fwd door section has two hinges which are made of titanium-6Al-4V alloy. The hinges may be susceptible to damage since the longeron by which they are supported also react fuselage torsional loads, support flight and purge pressure loadings at $Y_{\circ} \pm 105$, $Z_{\circ} 410$, and fus stations $X_{\circ} 621, 692, 805, \text{ and } 875$. Aft radiator panels are structurally attached to the payload doors and have no hinges.

DEFECTS: Cracks may occur in the bolt holes where the hinge mechanism attach to the hinge longeron and radiator panels, and at the hinge pivot joints.

NDT TECHNIQUES: Primary: Ultrasonic shear wave (para. 1.5.5.3 B) for hinge pivot joints, eddy current (para. 1.5.4.4) for hinge-longeron/radiator attachment areas.

INSPECT AROUND PIN HOLES
AT HINGE POINTS

FORWARD PAYLOAD
BAY DOOR RADIATOR
HINGES, 4 PER SIDE

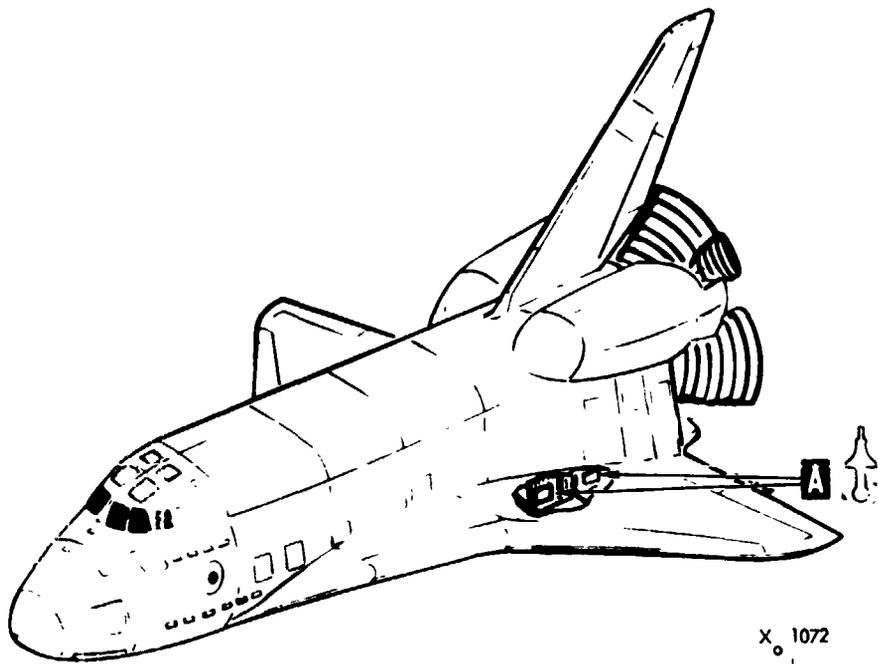
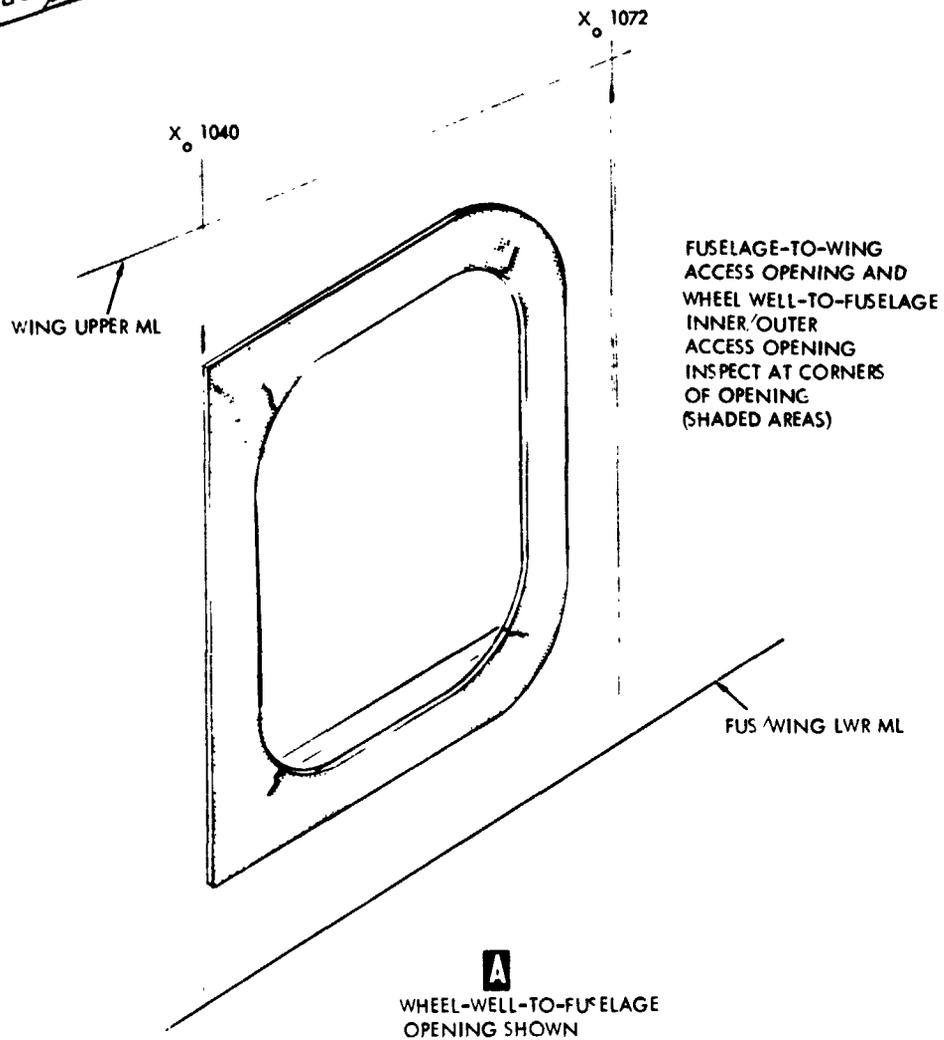
Figure 3-6. Frame Corners, Inner/Outer Access Opening

COMPONENT/AREA DESCRIPTION: FRAME CORNERS, WHEEL WELL FUSELAGE INNER/OUTER ACCESS OPENINGS. The access opening in the mid-fuselage, wheel well area, is centered at $X_o = 1055$, $Y_o = 105$, $Z_o = 296$. Since the opening is a penetration into highly loaded primary structure, stress concentrations, around the opening may eventually result in fatigue damage to the frame, stringers and/or fittings used to form the opening sill. The material of construction is 2024 aluminum alloy with a zinc chromate primer and Supercorapon 515-700 finish.

DEFECTS: Edge cracks and cracks around fastener holes in the attachment areas at the corners of the sill frame structure; also in the webs of corner attachment fittings.

NDT TECHNIQUES: Primary: Eddy current (para. 1.5.4.4)
Backup: Fluorescent penetrant (para. 1.5.2.1 Fig. 1-9)
requires paint stripping.

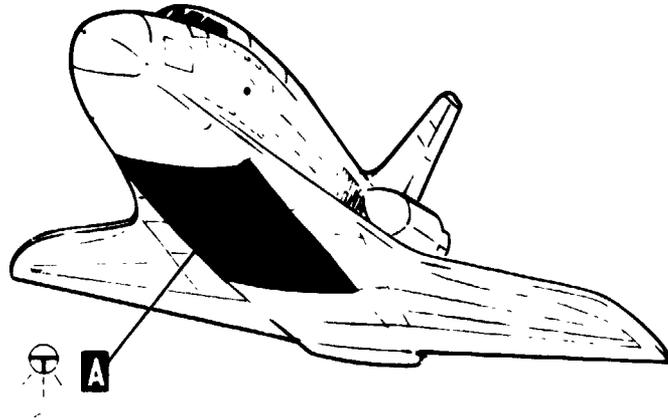
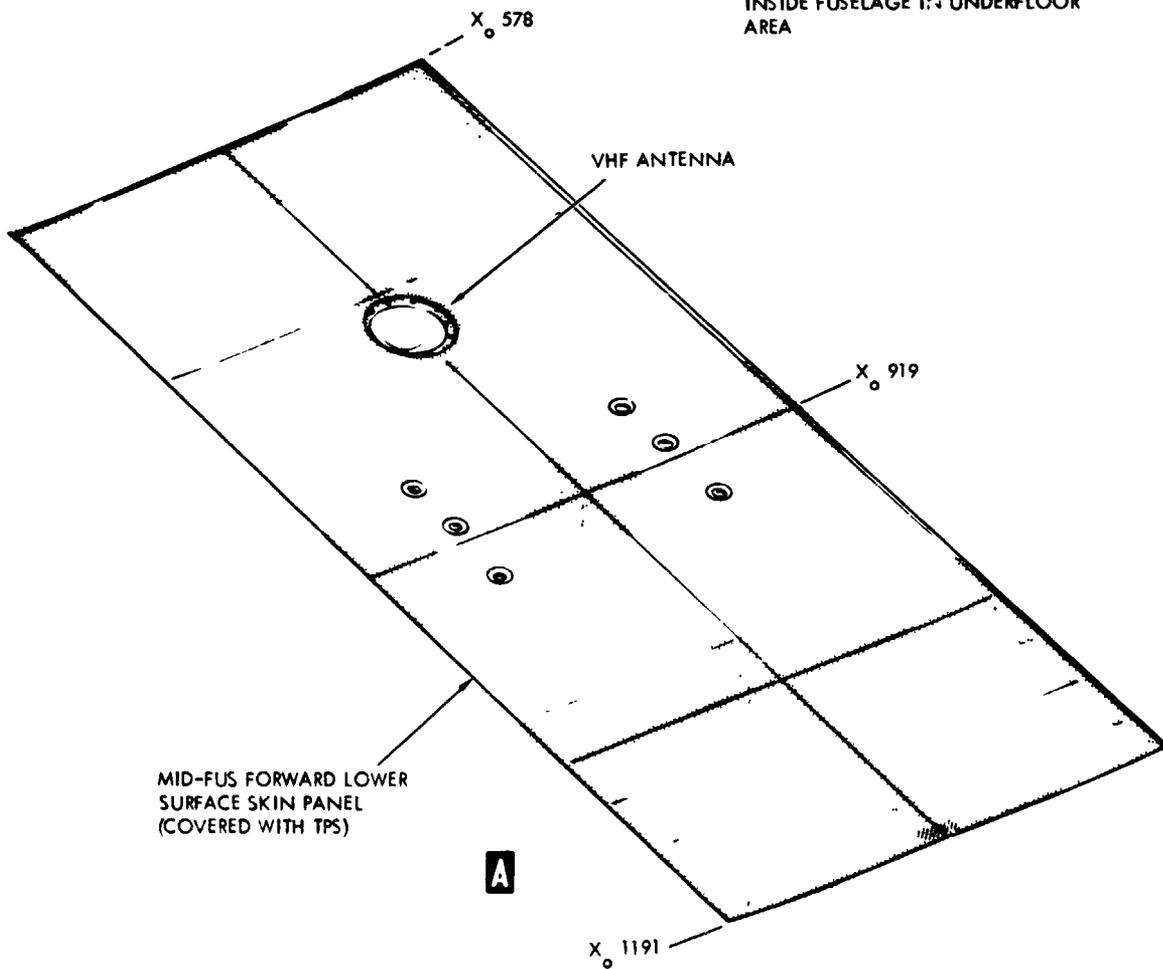
Figure 3-7. Mid-Fuselage Lower Skin Panels

COMPONENT/AREA DESCRIPTION: LOWER SKIN PANELS. The mid-fuselage lower skin panels are made from 2124-T851 aluminum alloy machined plate. The skins are located along the bottom of the fuselage, extending from $X_{\circ} 578$ to $X_{\circ} 1191$ and from $Y_{\circ} (\pm)105$ to $Y_{\circ} (-)105$. Compressive tensile and torsional loads due to tail-down landing and gust loads may produce damage in certain areas. The skin panels should be inspected along transverse splices at $X_{\circ} 578$, $X_{\circ} 919$ and $X_{\circ} 1191$; and longitudinal splices at $Y_{\circ} \pm 105$ and $Y_{\circ} 0.0$; and around cut-outs.

DEFECTS: Through-cracks at rivet/fastener holes along the splices and around the periphery of cut-outs.

NDT TECHNIQUES: Primary: X-ray radiography (para. 1.5.6.2) along all areas.
Backup: Remove local TPS in suspect areas and use eddy current surface probe (para. 1.5.4.4)

PLACE X-RAY TUBE OUTSIDE FUSELAGE

PLACE X-RAY FILM NEXT TO SKIN
INSIDE FUSELAGE IN UNDERFLOOR
AREA

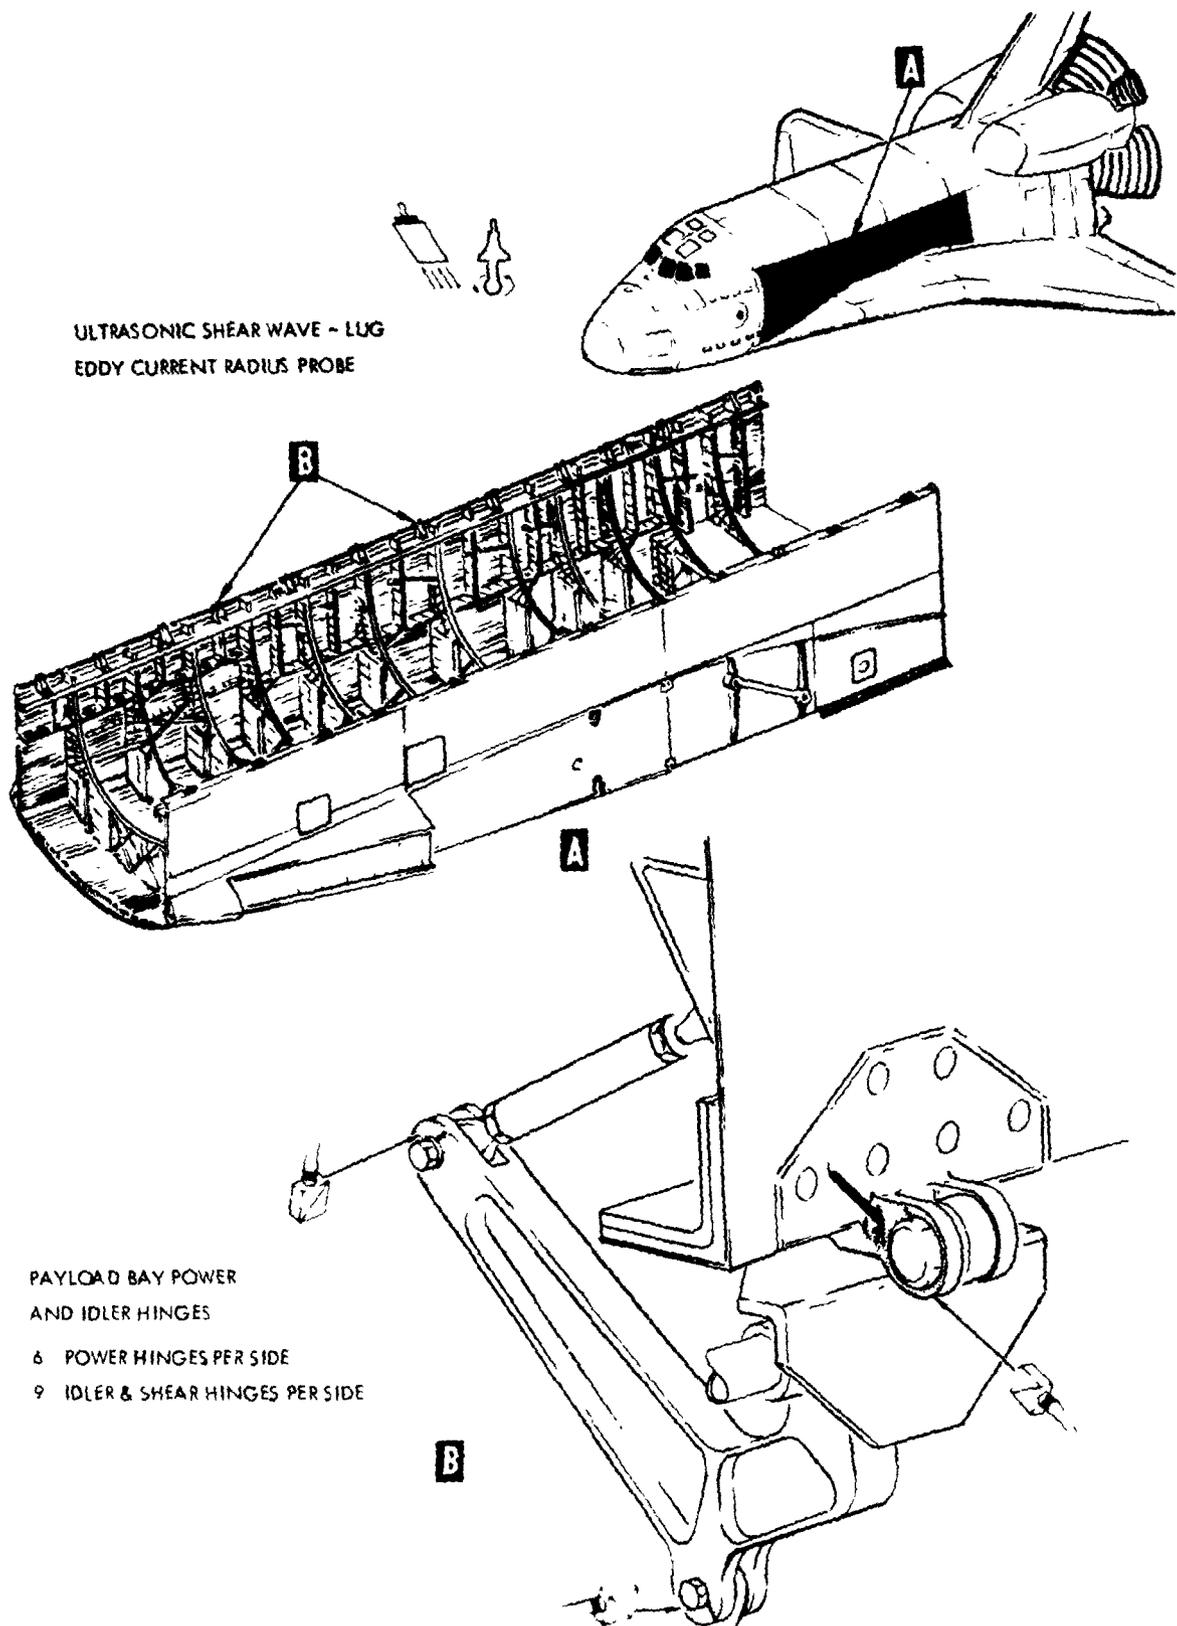
Figure 3-8. Payload Bay Power and Idler Hinges

DEFECTS: Cracks may occur in the bolt holes where the hinge mechanism attaches to longeron sill and payload doors.

NDT TECHNIQUES: Primary: Ultrasonic shear wave (para. 1.5.5.3 C) and fluorescent penetrant (para. 1.5.2.1 Fig. 1-9).

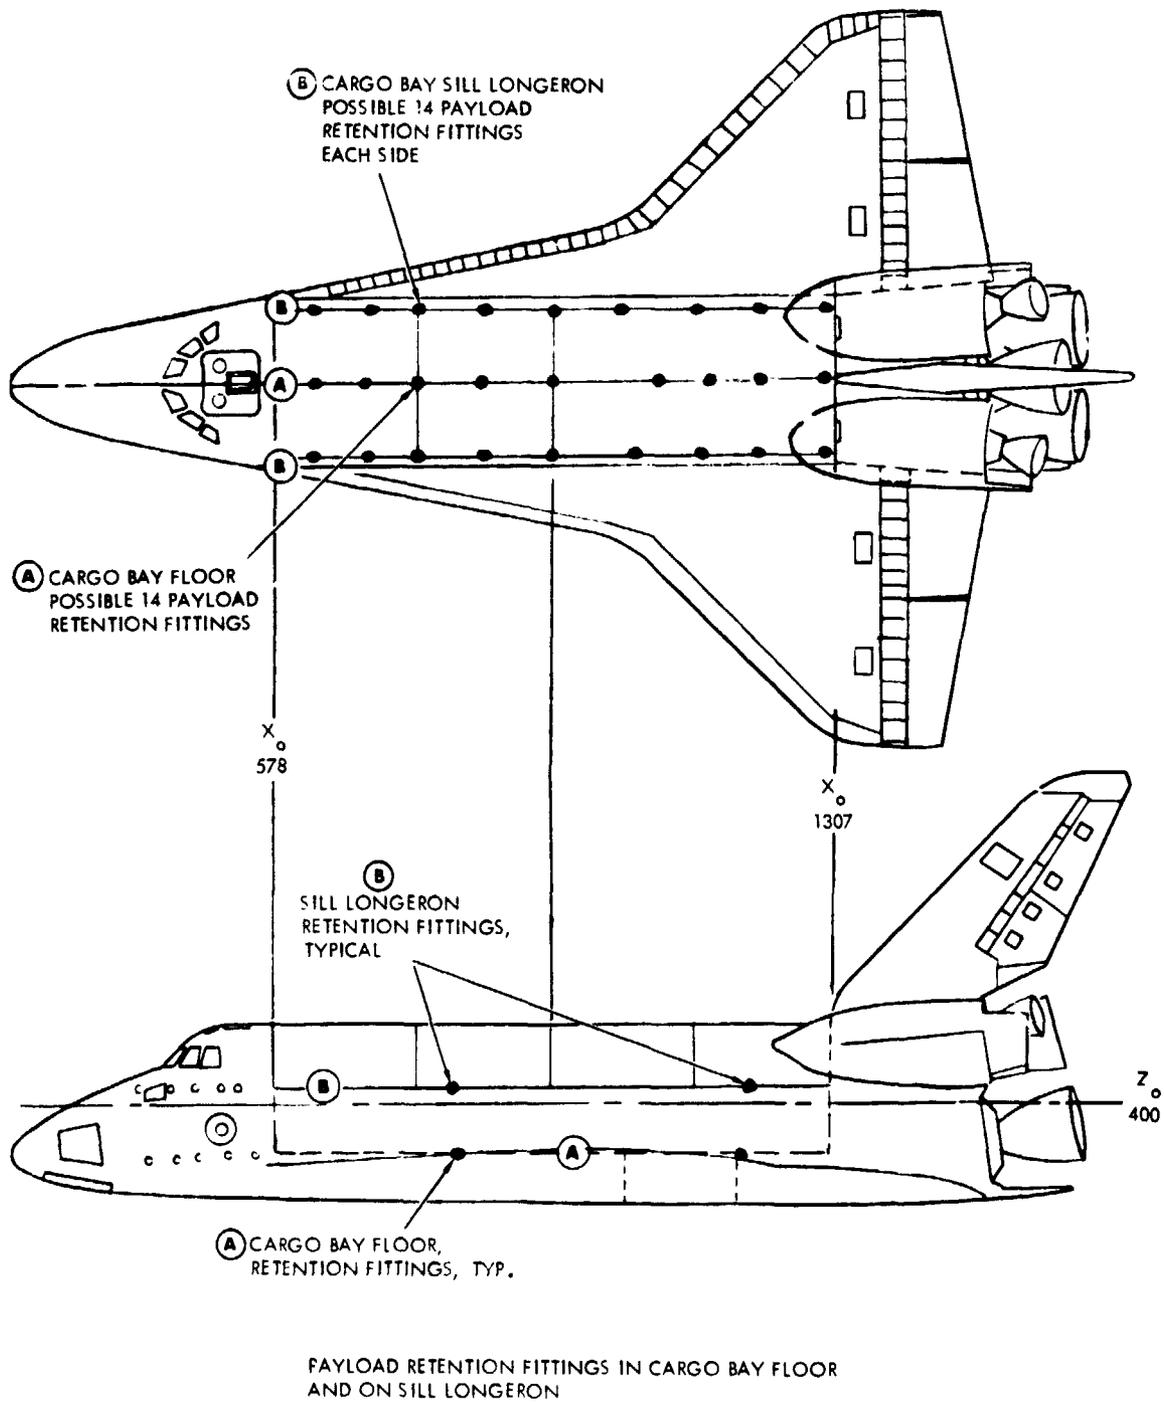
Figure 3-9. Payload Bay Sideload Retention Fittings

DEFECTS: Cracks may occur at the base of the receptacle and at the upper or lower outboard web-to-flange transitions on the fitting.

NDT TECHNIQUES: Primary: Ultrasonic shear wave (para. 1.5.5.3) or eddy current (para. 1.5.4.4) for receptacle.

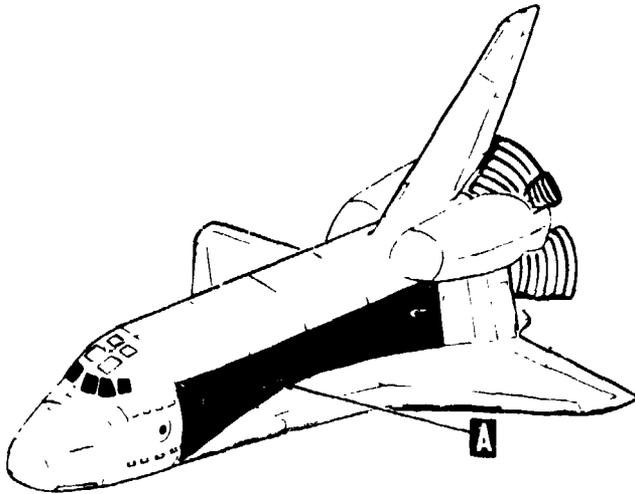
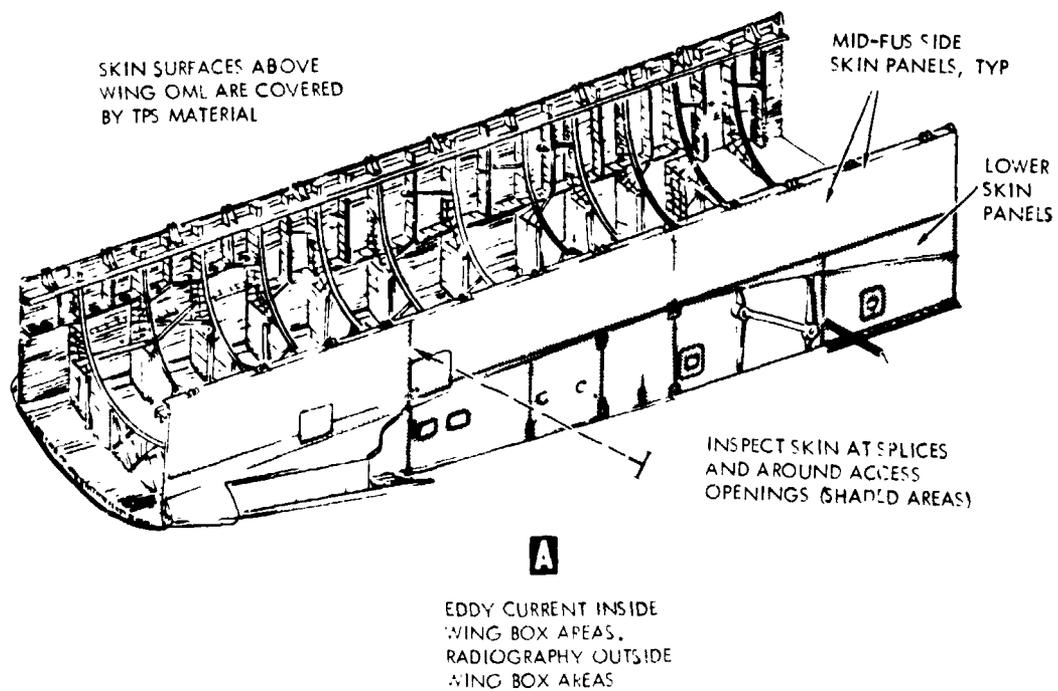
Figure 3-10. Mid-Fuselage Side Skin Panels

DEFECTS: Through-cracks at rivet/fastener holes near splices and clevis attach fittings and at corners or edges of access openings and cut-outs.

NDT TECHNIQUES: Primary: X-ray radiography (para. 1.5.6.2) for areas above wing mold line where TPS reduces access. Areas below wing mold line can be inspected visually and by eddy current technique (para. 1.5.4.4).

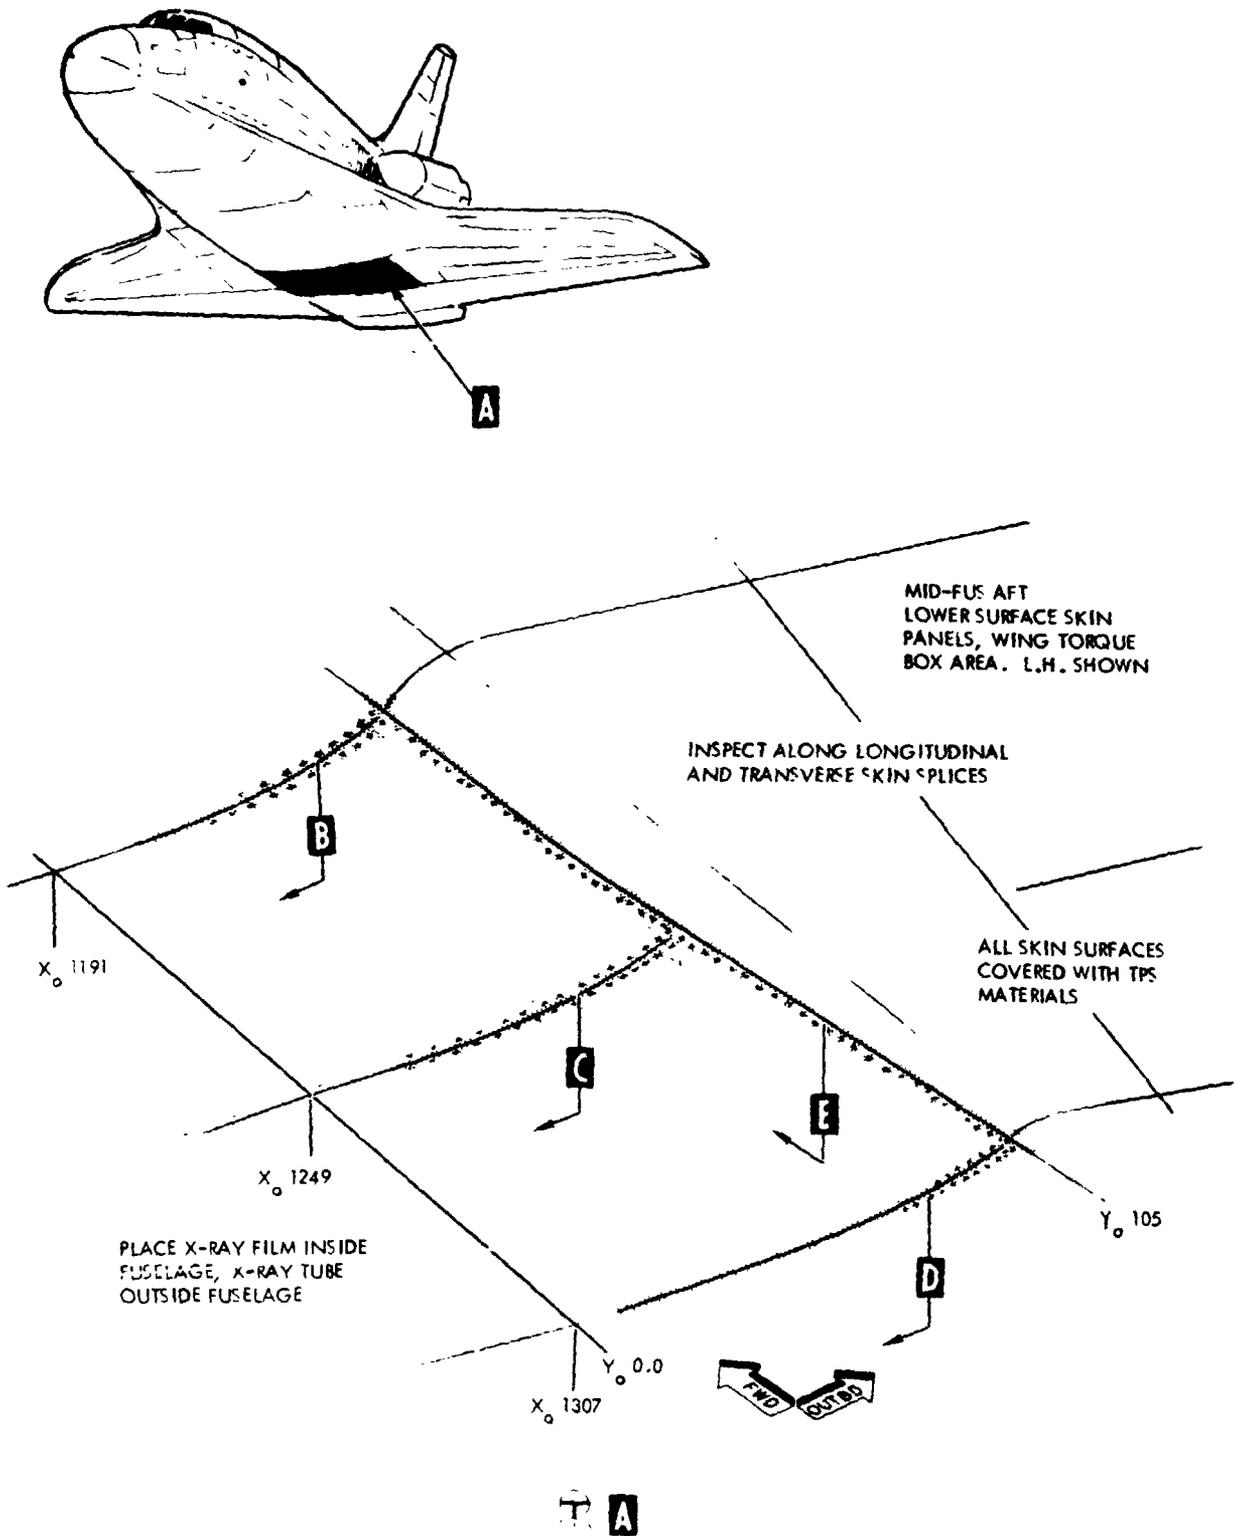
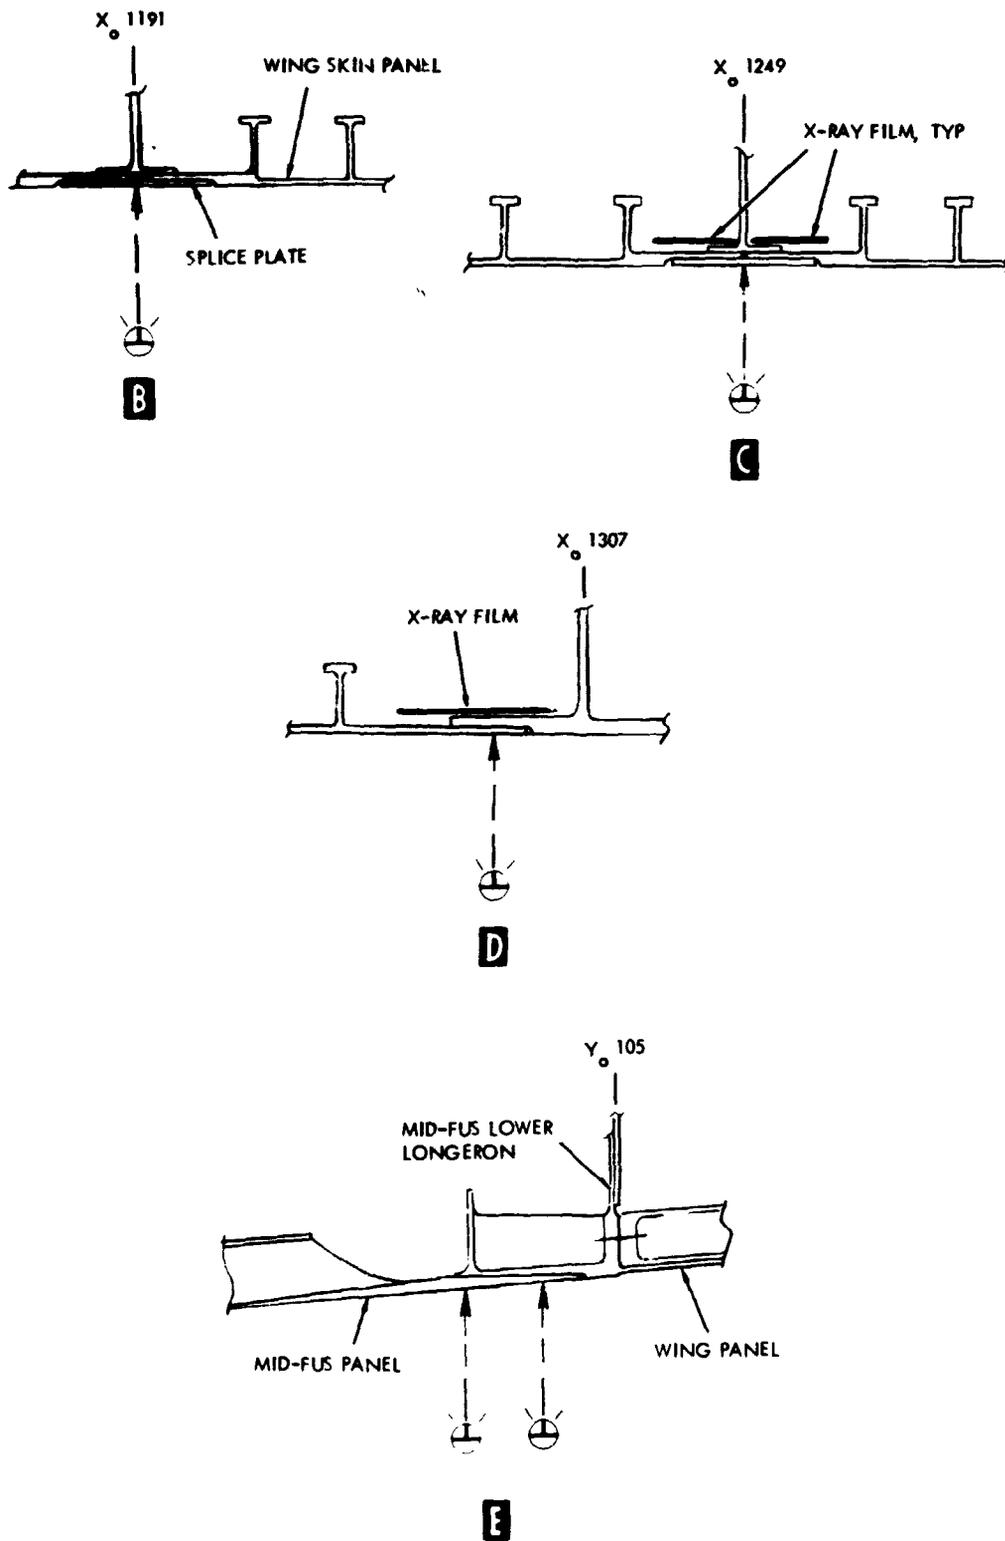
Figure 3-11. Mid-Fuselage Wing Carry-Through Skins (Sheet 1 of 2)

These panels, forming the bottom surface of the wing torque box, are machined from 2124-T851 aluminum alloy plate, and contain integral stiffeners. They are located between $X_{\circ} 1191$ and $X_{\circ} 1307$, and extend from $Y_{\circ} -105$ to $Y_{\circ} +105$. They receive tension and torsional loads from tail-down landings and aerodynamic forces which may produce damage along panel splice and attachment areas. Panel transverse splices at $X_{\circ} 1191$, $X_{\circ} 1249$, and $X_{\circ} 1307$ and longitudinal splices at the cargo bay sidewalls should be inspected.

DEFECTS: Corner or edge cracks at fastener holes in splice tangs. Cracks at runout of integral stiffeners.

NDT TECHNIQUES: Primary: X-ray radiography (para. 1.5.6.2) for skin splices. Eddy current (para. 1.5.4.4) or ultrasonic (para. 1.5.5.3 C) for stiffener runouts.

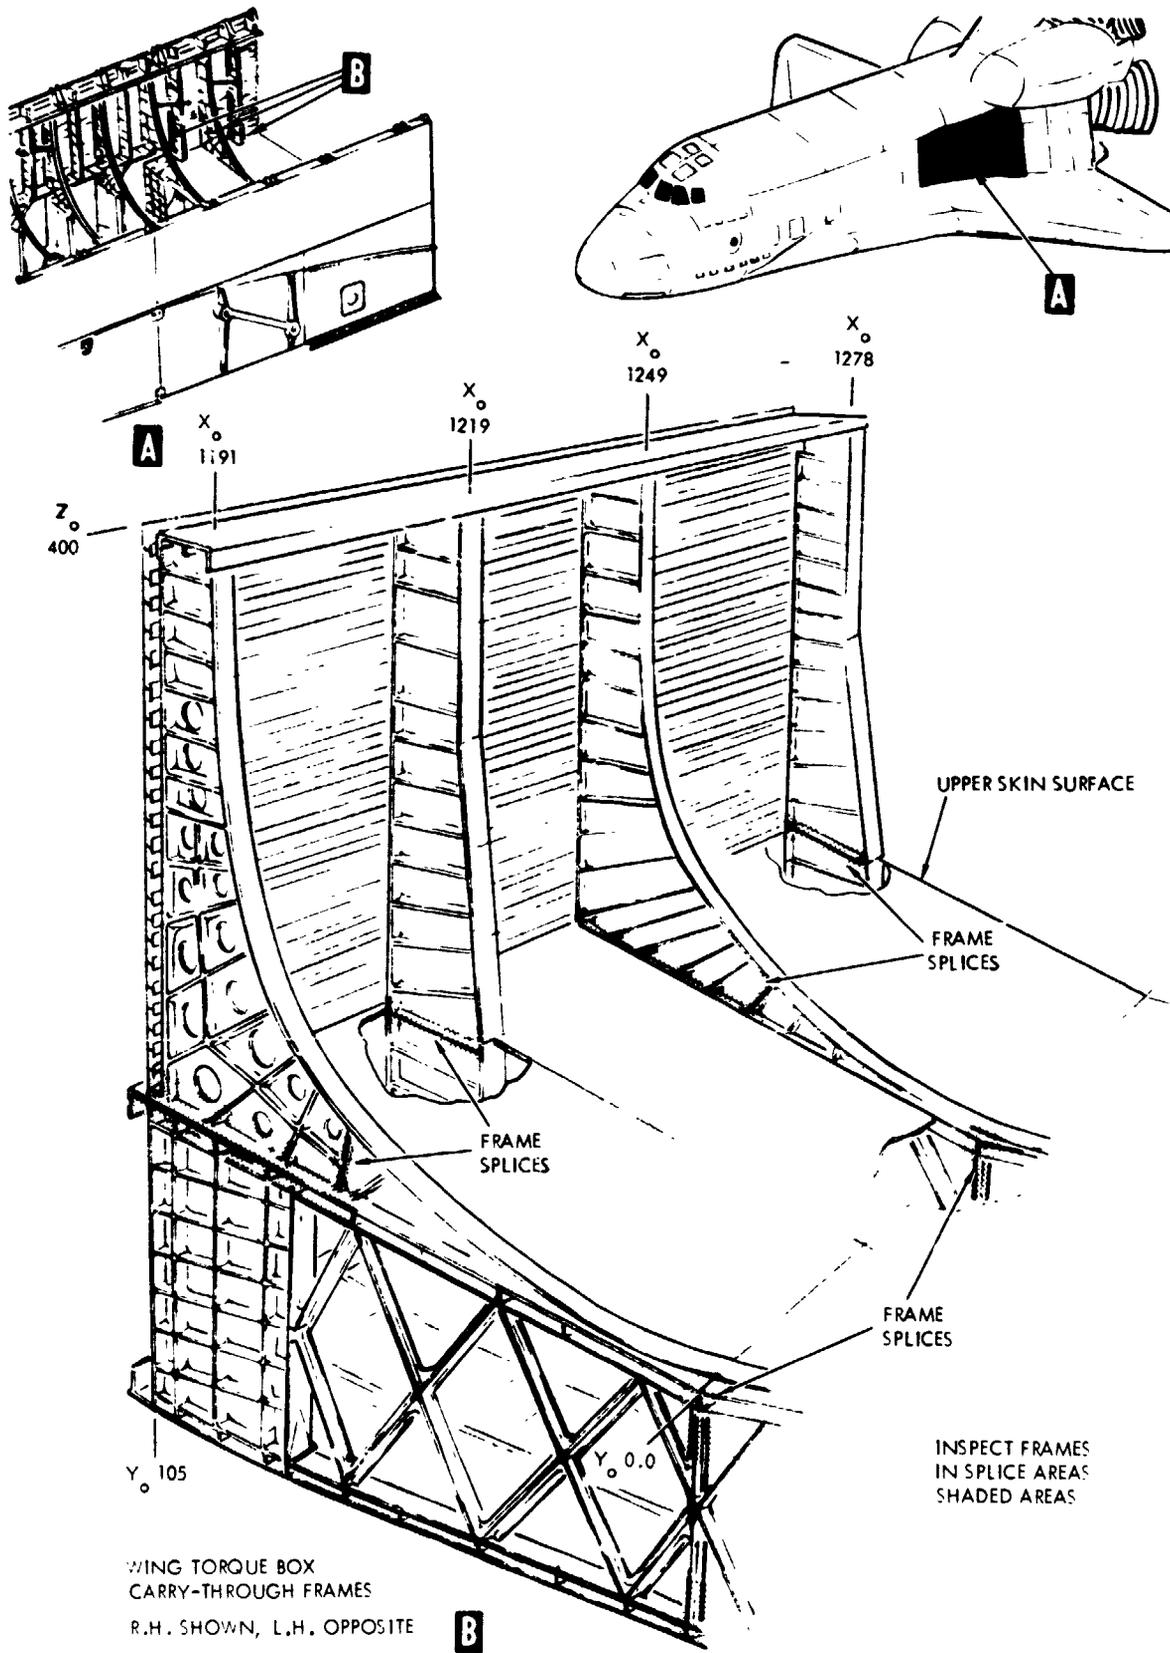
Figure 3-12. Wing Carry-Through Spar Frames

These frames are machined from 2124-T851 plate and are given a zinc chromate primer and Supercorapon 515-700 finish. The most critical load condition for these safe life components is bending during high-q boost and 2.5G maneuver. Fatigue damage could eventually result in splice areas of the frames. The wing torque box is integrally built into the mid-fuselage and contains two wing support frames and two intermediate frames in which wing loads are dominant. The description covers the two wing support frames at X_{\circ} 1191 and X_{\circ} 1249.

DEFECTS: Radial cracks at fastener holes in frame splice areas. Cracks generally oriented fore/aft.

NDT TECHNIQUES: Primary: Ultrasonic shear wave (para. 1.5.5.3 C) and/or eddy current surface probe (para. 1.5.4.4) (for cracks extending beyond fastener heads/nuts).

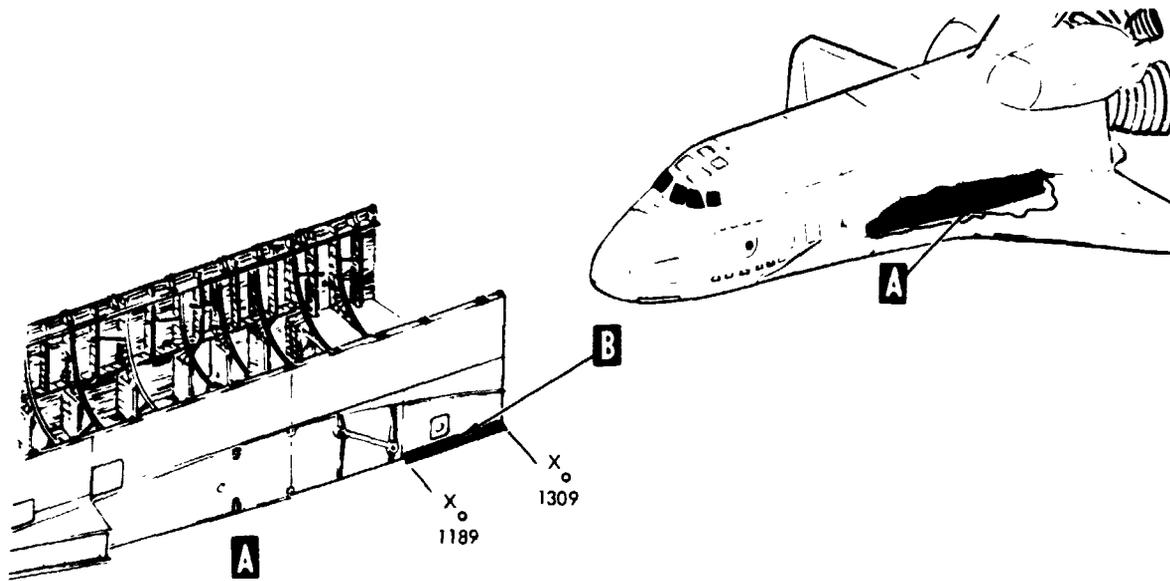
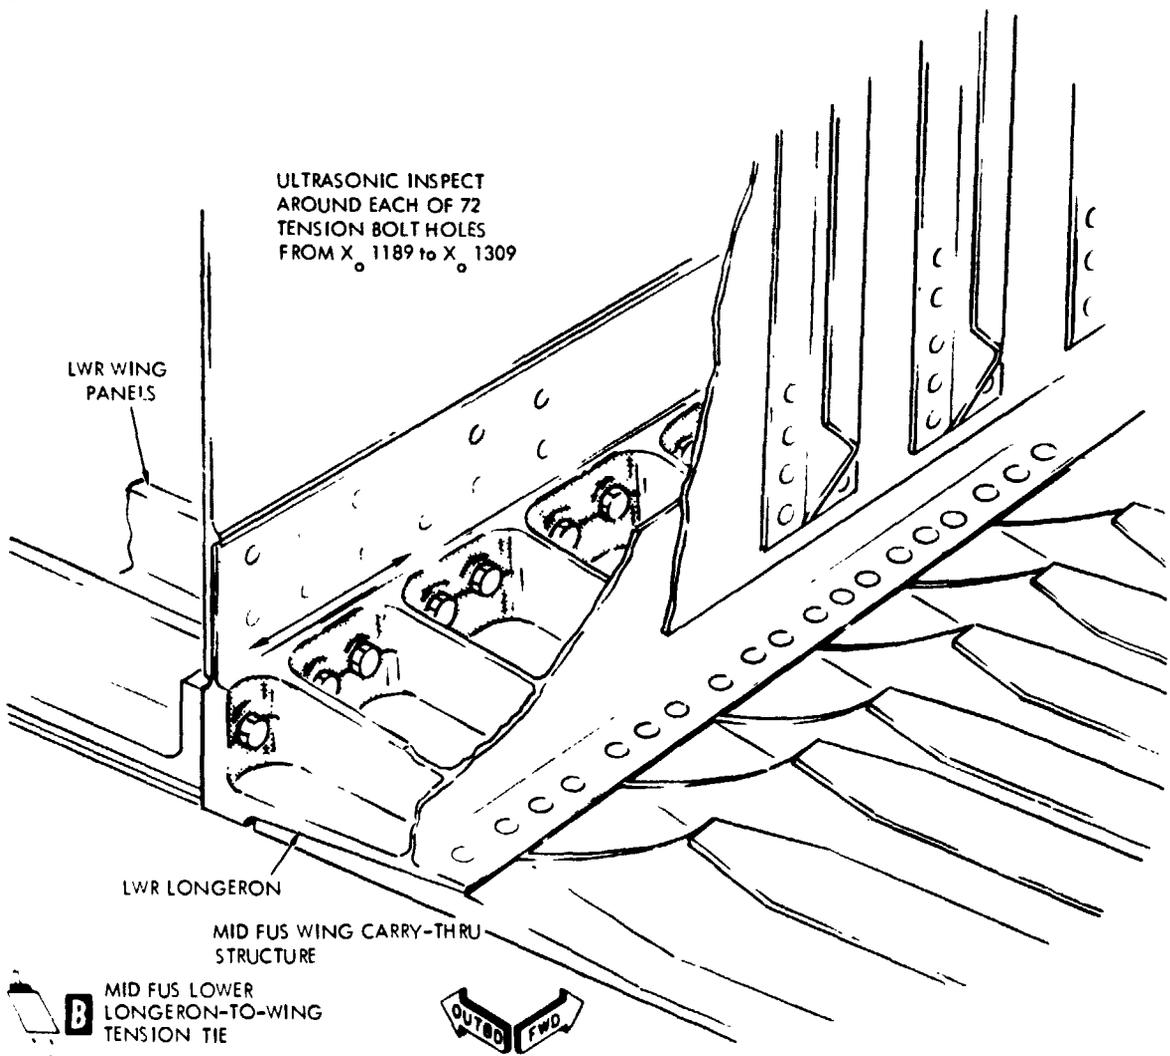
Figure 3-13. Wing/Fuselage Lower Aft Longeron Tension Tie

DEFECTS: Fatigue cracks may occur around the tension bolt holes in either the wing skin or mid-fuselage longeron.

ACCESS: The holes are to be inspected on both sides of the interface. Enter the mid-fuselage crawl space through the MLG wheel well-fuselage access opening at X_o 1055, and enter the wing through the wing-to-fuselage aft access opening at X_o 1238. For backup inspection, the tension bolt in the suspect hole must be removed.

NDT TECHNIQUES: Primary: Ultrasonic shear wave (para. 1.5.5.3 C)
Backup: Eddy current bolt hole (para. 1.5.4.3)

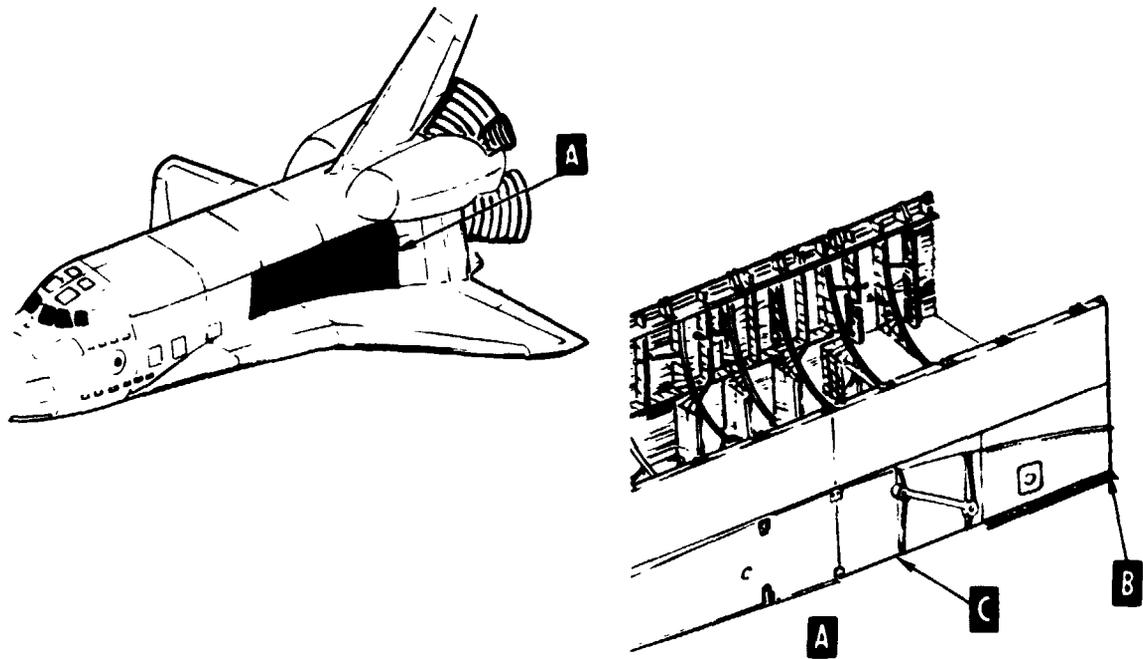
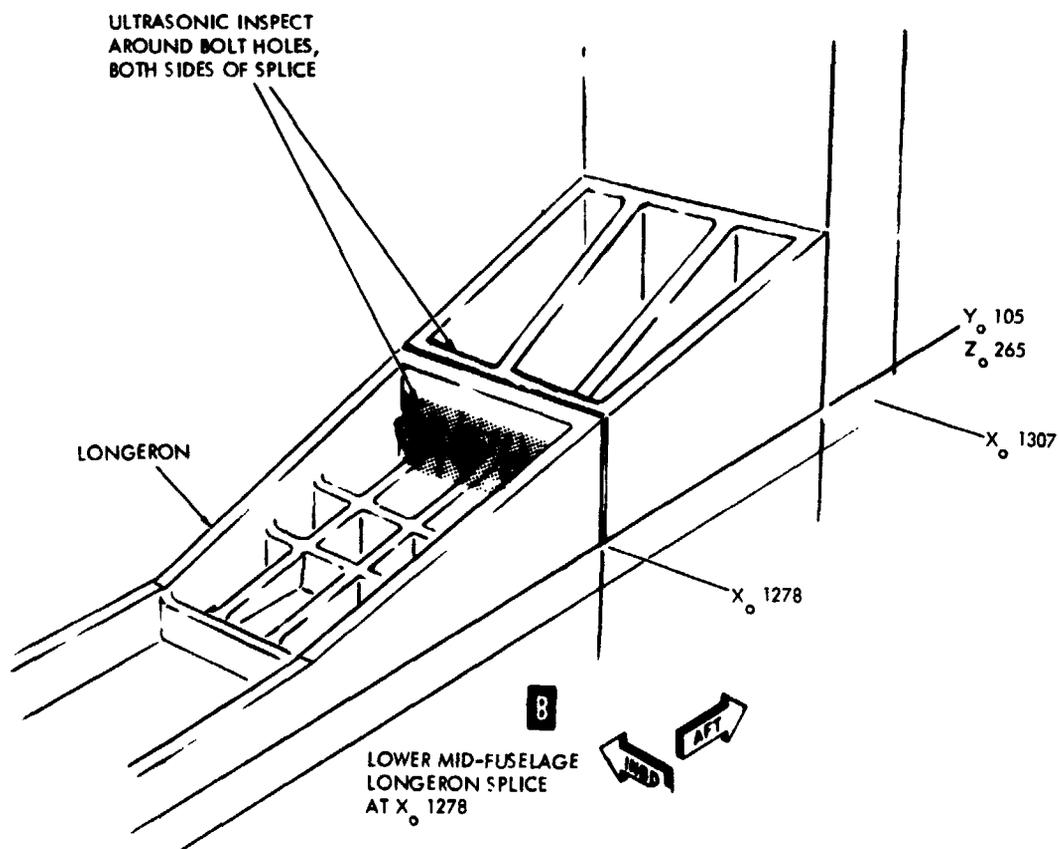
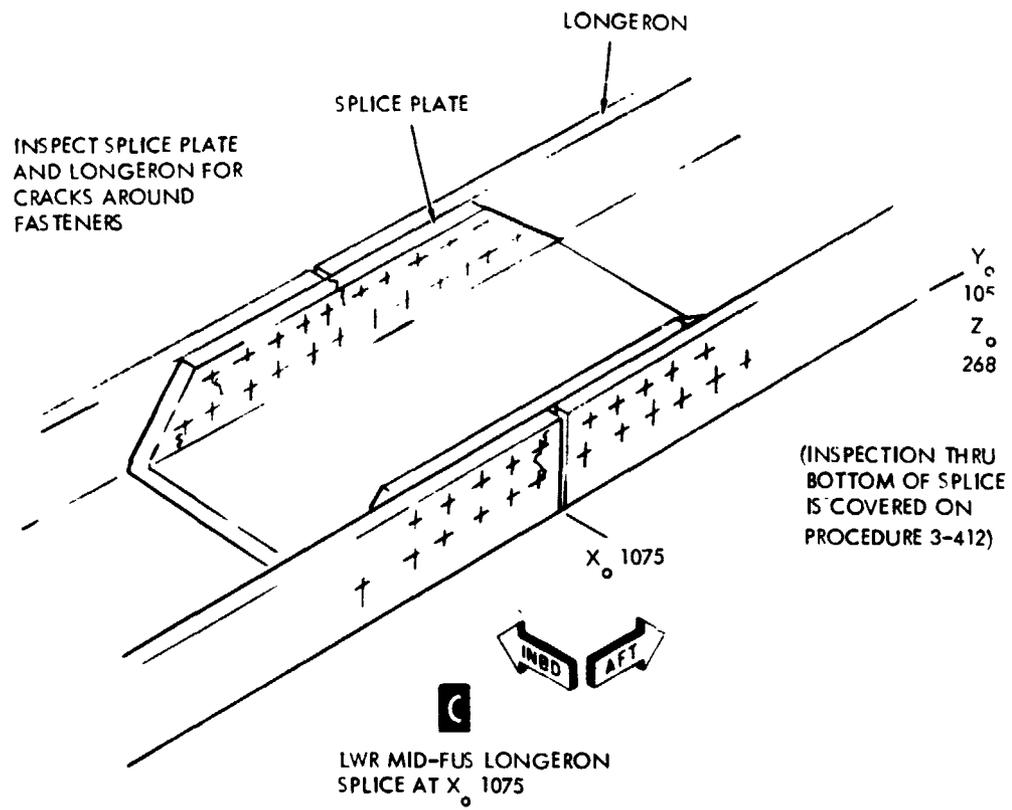
Figure 3-14. Mid-Fuselage Lower Aft Longeron (Sheet 1 of 2)

DEFECTS: Horizontal and vertical cracks around the splice bolt holes at $X_{\circ} 1278$; cracks around fastener holes at the longeron splice at $X_{\circ} 1075$.

NDT TECHNIQUES: Primary: Ultrasonic shear wave (para. 1.5.5.3 C)
(Fastener holes at non-splice areas are covered by radiographic inspection of wing carry-thru lower skin panel procedure).
